A **Trapzilla** CASE STUDY

DELL® IRELAND

TZ-600 Provides Economical, Efficient Solution to Replace Leaking Grease Interceptor

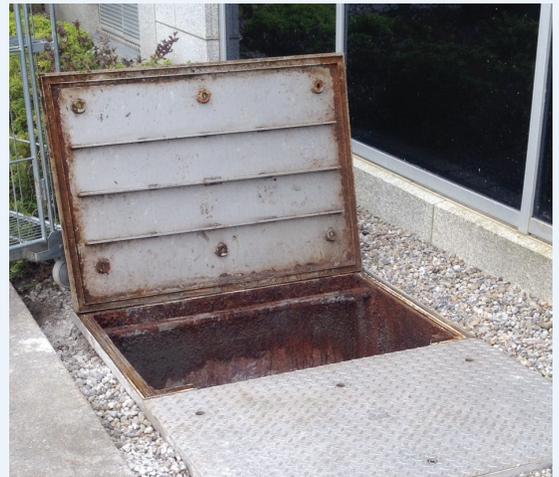
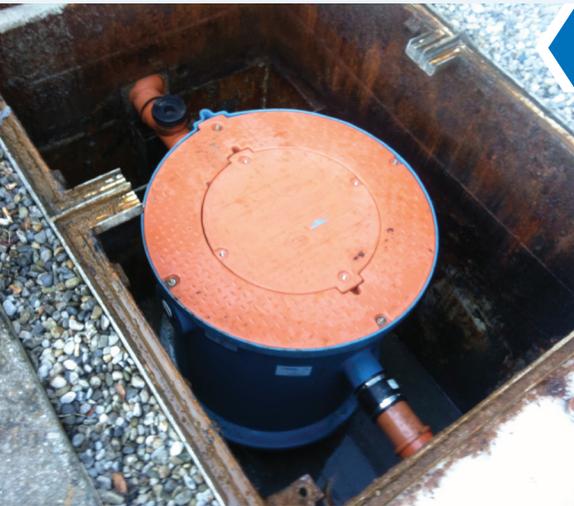
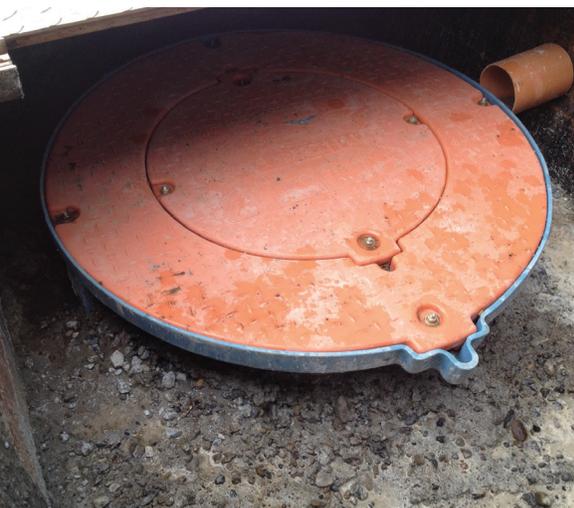
The building had a metal grease trap that had been installed about 10 years earlier. The combination of moisture and the acid that builds up naturally in grease interceptors was slowly breaking down the metal trap's structure, and the trap was starting to corrode and rust, as metal grease interceptors often do.

Kitchen effluent was leaking from the grease trap into the soil around it, creating a large, permanent wet patch of ground. This patch of ground was unsightly for one of the world's most successful technology companies. A bigger problem was the potential for regulatory issues with the local authority responsible for grease disposal. As the trap started to degrade, there was a strong possibility that grease, rather than being trapped in the interceptor, would escape into the local sewage treatment system.

The TZ-600 was placed inside the old metal trap. That meant Dell could use the existing plumbing lines with minimal changes.

ProViro's crew removed the baffles in the existing metal trap and simply positioned the new TZ-600 in place. They poured concrete around it to secure the new interceptor.

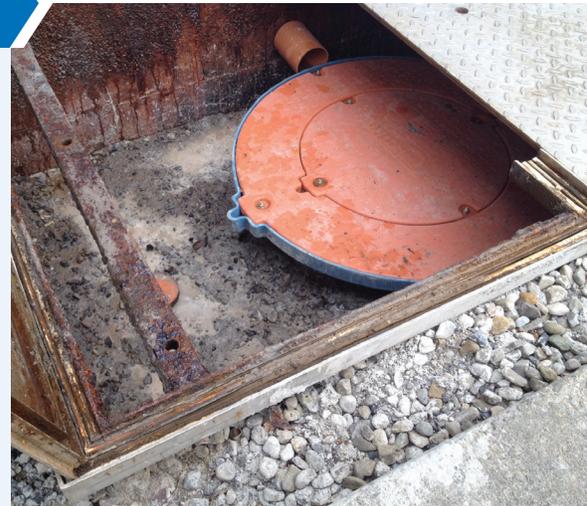
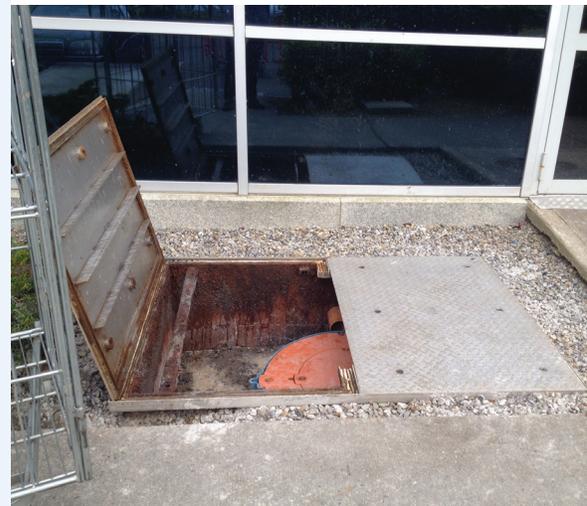
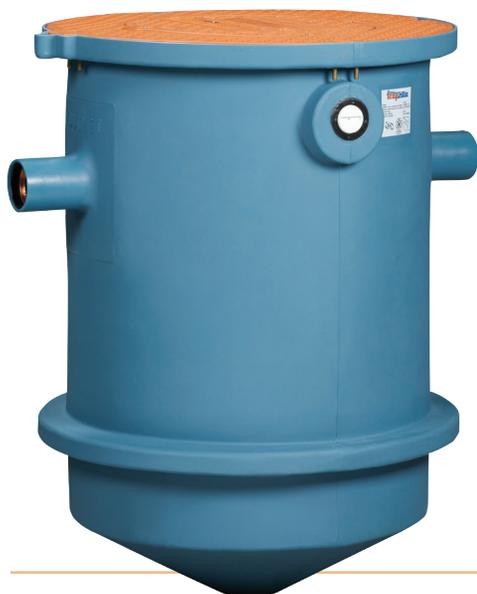
This creative installation meant that the old trap didn't have to be removed, and no new excavation was required. As a result, the installation was faster, less expensive and less disruptive than you would expect a new grease trap installation to be.

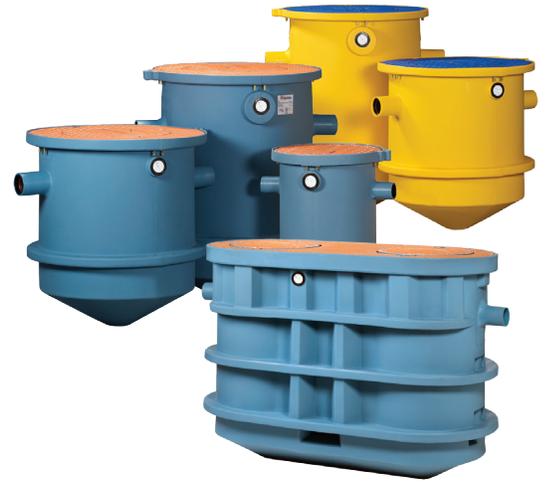
An Upmarket Nursing Home

An upscale nursing home was installing a new sewage treatment system, which required a grease trap to keep the new system operating efficiently. Before this, the nursing home had never needed a grease trap. The home installed a TZ-1826, a super-capacity Trapzilla interceptor that can trap and store as much grease as a 3,785L concrete trap in just a fraction of the space.
